NBSIR 76-1025

Air-Mobility Rigid Shelter Systems

November 1975

An Interim Report

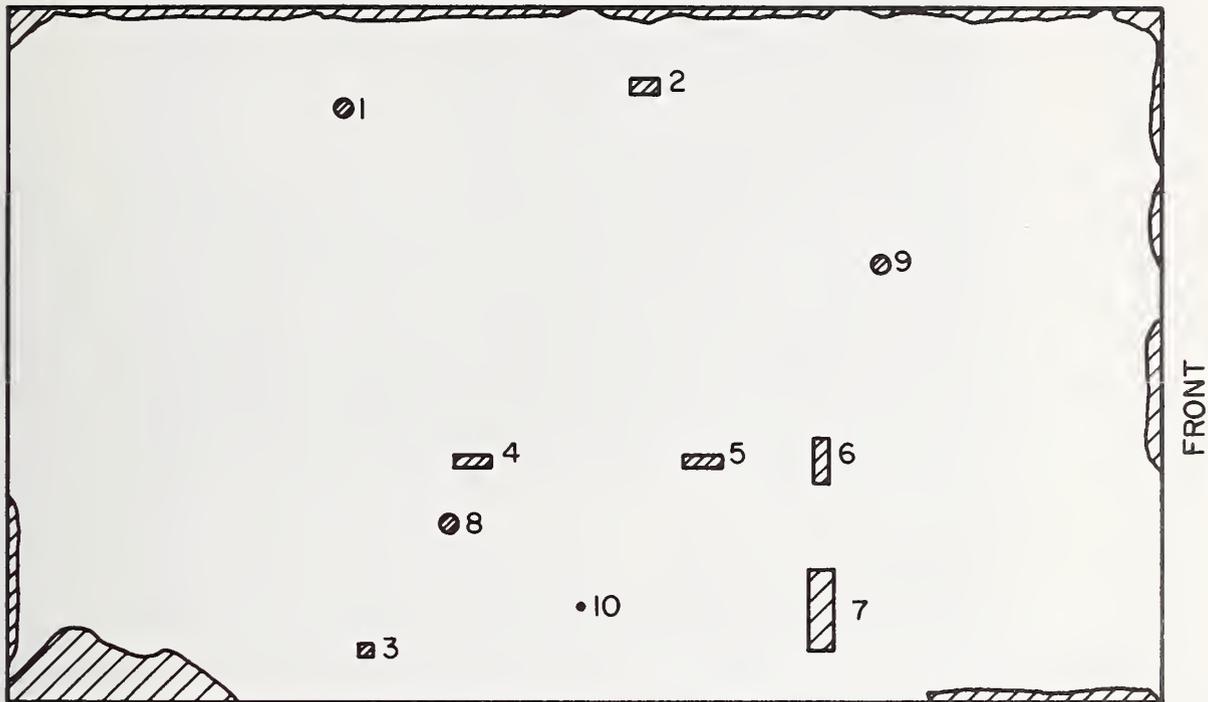
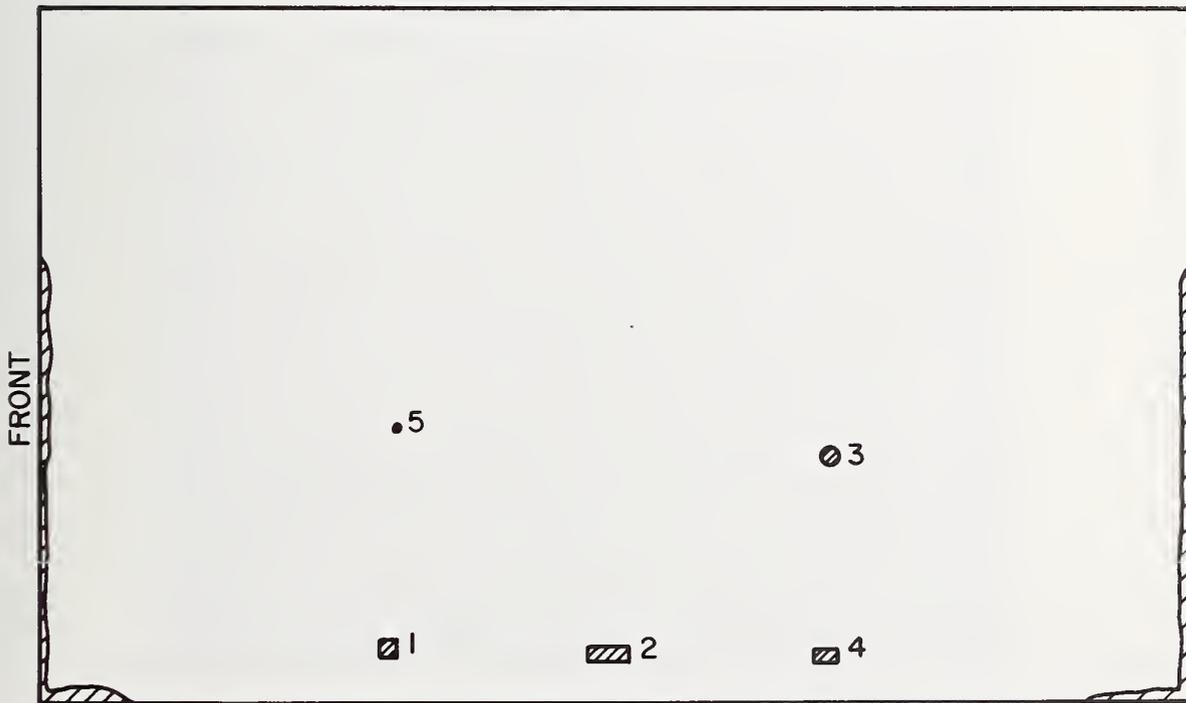
Fig. 2.15 Indentations and Delaminations,
EXP Shelter 285

Table 2.2 is a listing of the indentations and damaged areas found on units 285 and 267. Locations of these areas and delaminations are indicated in figures 2.15 and 2.16. The panel "names" given to the individual panels are those used by the field personnel. "Interior floor" panel means the fold-down floor panel which is closest to the center structure when the shelter is expanded. These two shelters were the outside (285) and middle (267) units of a three shelter assembly (see figure 2.2a). The most indentations occurred on the fold-down floor panel (interior or inboard floor panel when expanded) that is exposed to weathering during storage. Of all the indentations measured on the panels of both shelters, only one was deeper than 1/8 in. Three indentations were found on shelter 267, but with only one being of any consequence. The indentation at location 2 of 267 appeared to be caused by the fork of a lift truck. It was located adjacent to a designated lift point. The location of this indentation was such that measurement with available instrumentation was not possible but the estimated depth was about 1/4 in. Figure 2.17 is a photograph of a similar indentation from a lift-truck fork, but was in the front-end wall.

The most extensive delaminations were found about the periphery of the exterior facing of the left fold-down floor panel on the outside unit (No. 285). This is the facing that was exposed to weathering during storage. Over 60% of the length of the outside edge was delaminated approximately 1 to 2 inches in from where the aluminum skin was attached to the edge members. Of the panels protected during storage, the exterior facing of the right fold-down floor section of No. 285 was delaminated about 29% of the length of the edge.

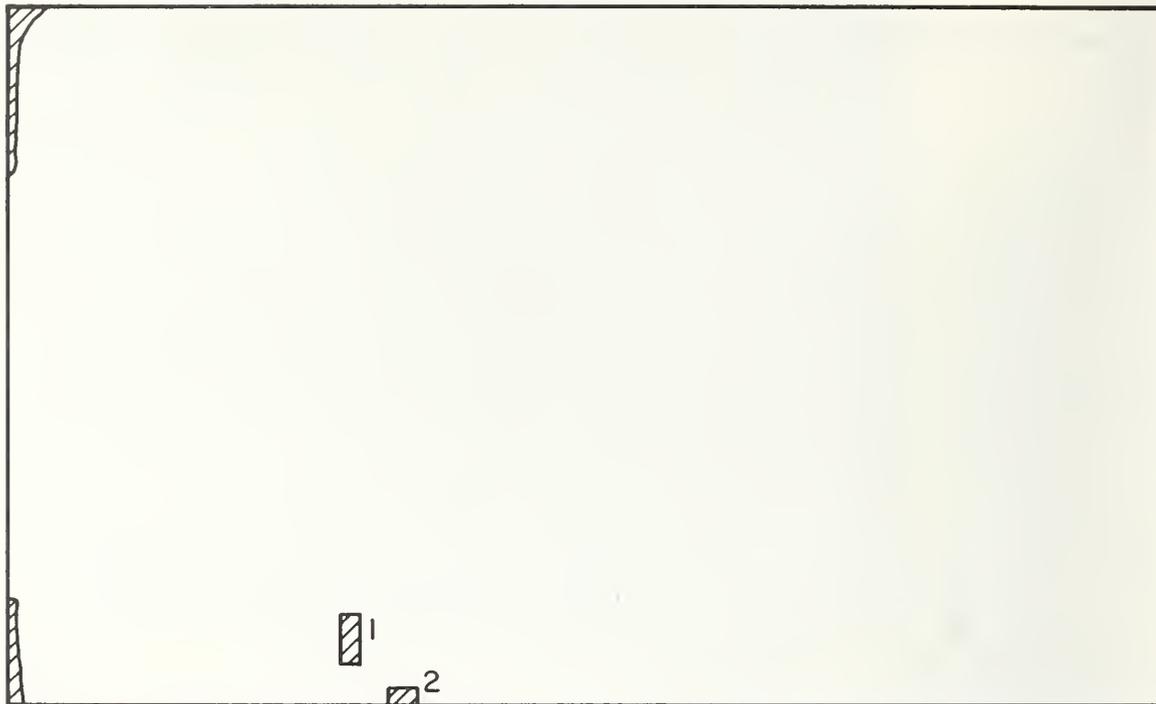
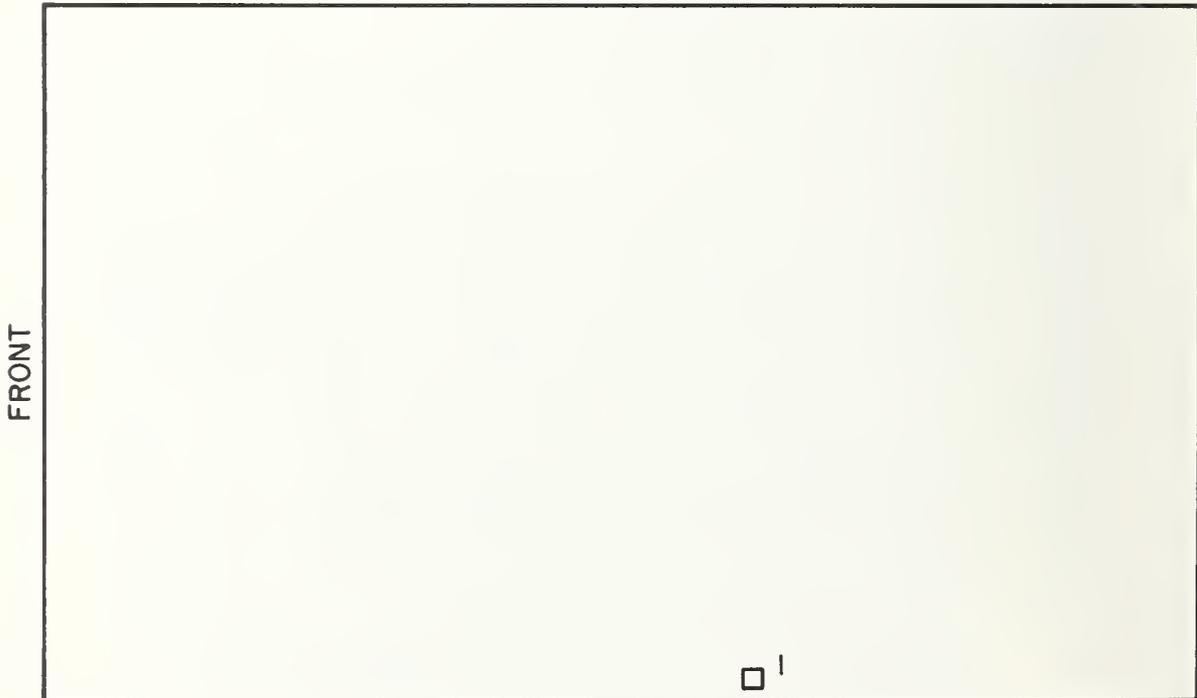
Fig. 2.16 Indentations and Delaminations,
EXP Shelter 267

The edges of the fold-down panels of shelter No. 267 (the center unit of the three shelter assembly) were delaminated for only 8% of the length on the left panel and none was found on the right panel. Figures 2.15 and 2.16 are scale drawings of the exterior facing of the fold-down floor panels for the two shelters and show the location of the indentations and the delaminated areas. No delaminations were found on any other panels in this shelter. No large areas of delaminations were found on the panels of these two shelters such as were observed on some other stored EXP's (see figure 2.19).

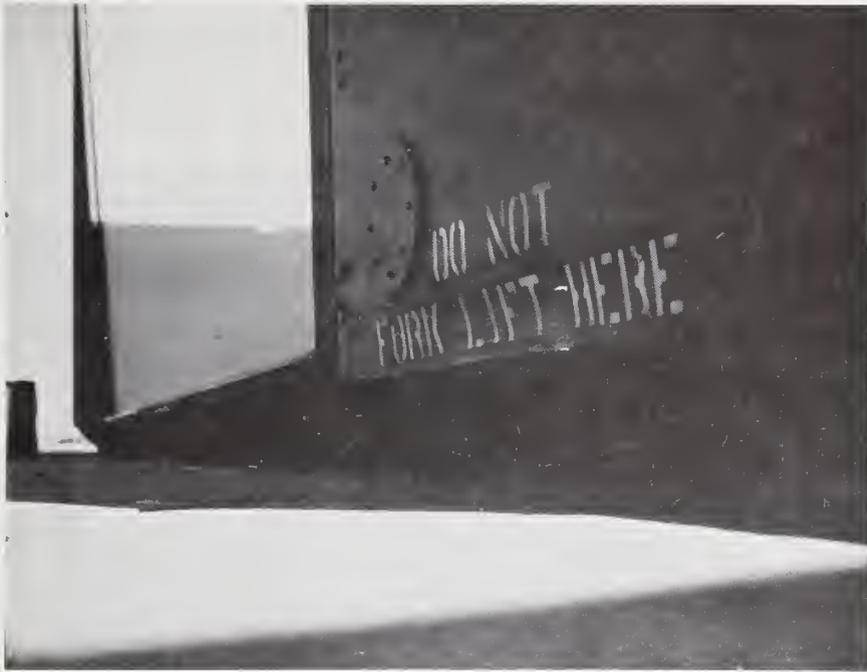
Fig. 2.17 Lift Truck Fork Damage

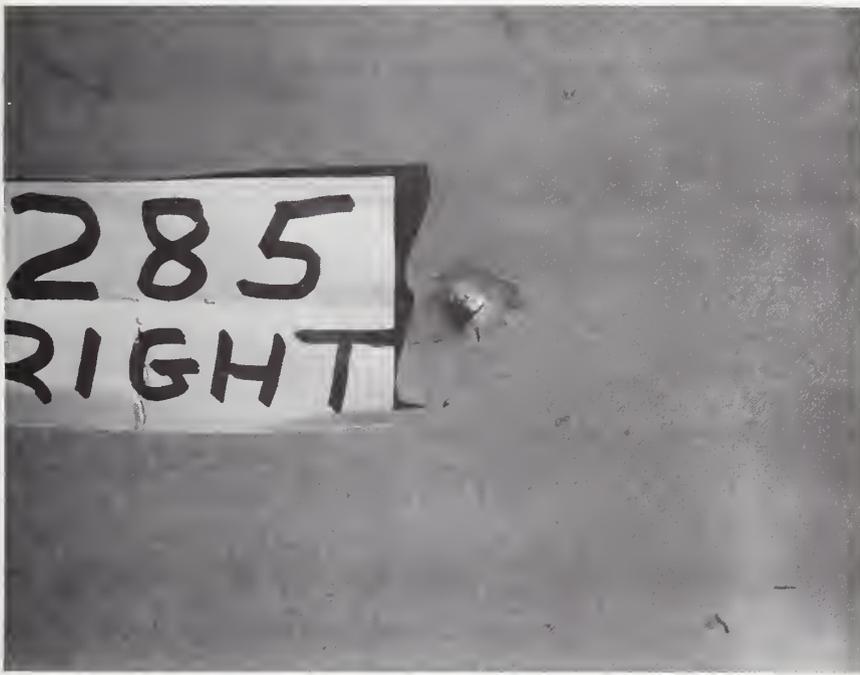
One puncture failure was found on the interior facing the fold-down panel of shelter 285. This penetration was triangular in shape and can be seen in Figure 2.18. A pencil probe inserted into the puncture extended all the way through the panel to the inside of the exterior facing.

Fig. 2.18 Puncture Damage, Floor Panel of EXP

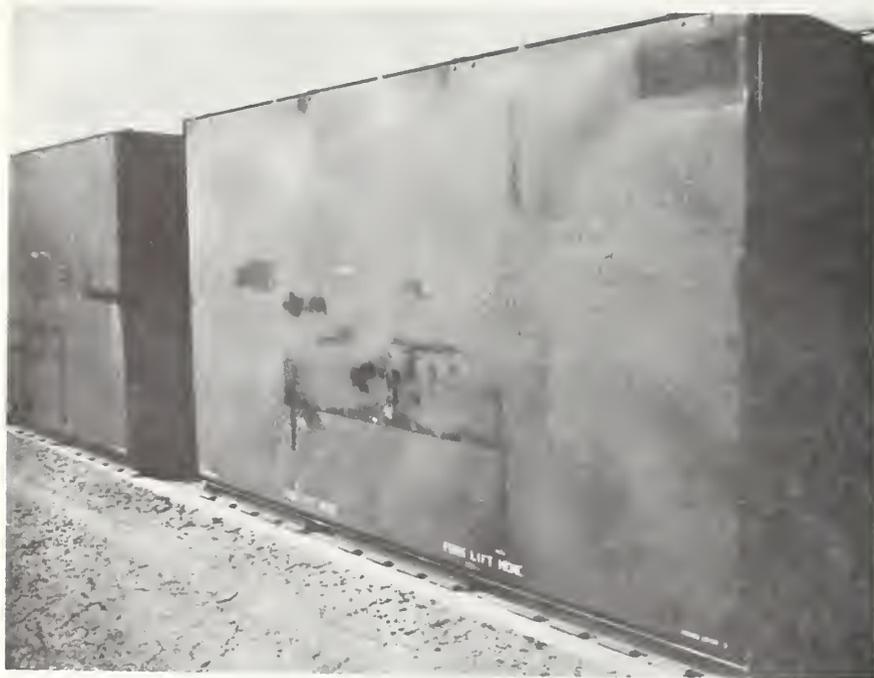
Fig. 2.19 Extensive Delamination of Interior Floor Panel of Stored EXP

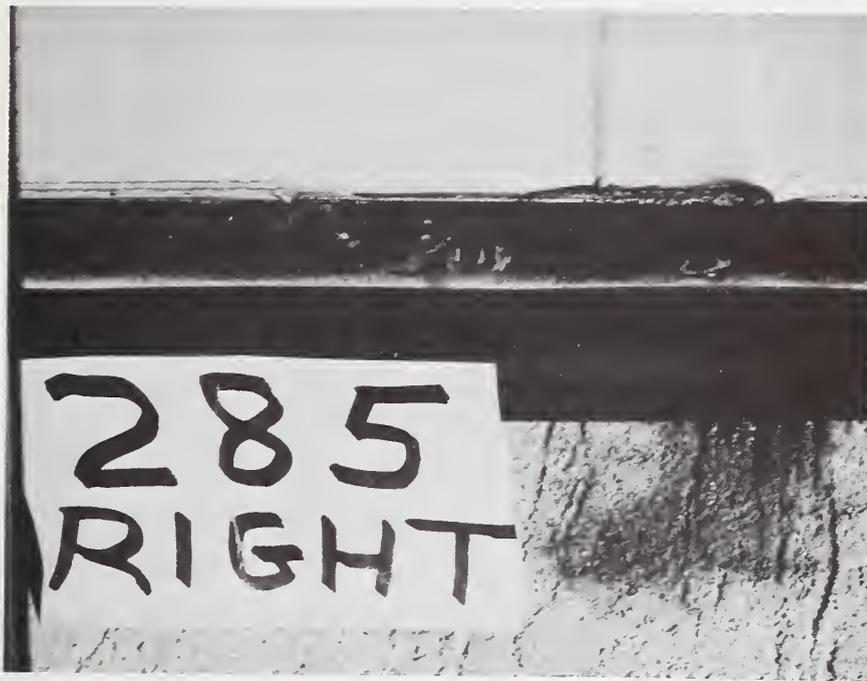
Figure 2.20 is a photograph of water leakage from the fold-down floor of shelter No. 285. No evidence of this leakage was apparent on the shelter while it was in the stored position, but when the shelter was opened for inspection of the interior surfaces, water ran from the delaminated edge of this floor panel. A pool of water approximately 8 inches in diameter resulted and the leakage continued for about an hour. Figure 2.21 shows a brown colored residue of leakage similar to that observed on several shelters that were in the storage area. In general, this staining was observed at the outer edge of the mid-height joint in the facing of the exposed floor panels (figure 2.22). (Weather side during storage). Figure 2.23 is a photograph of visible water seeping from a puncture in the skin of the fold-down floor panel of a stored EXP.

Fig. 2.20 Water Leakage at Mid-span Seam of Interior Floor Panel, EXP 285

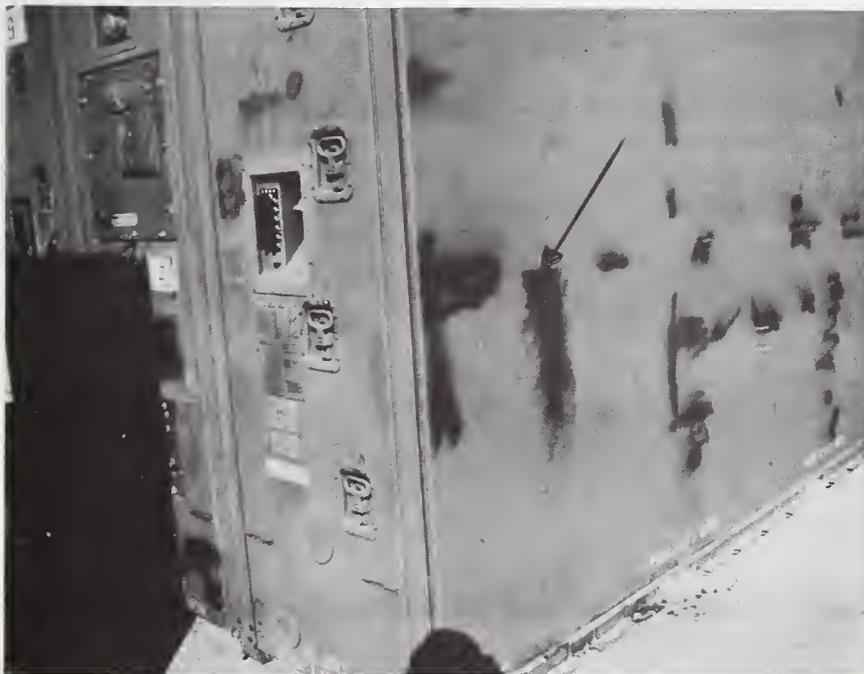
Fig. 2.21 Brown Leakage Stain Emanating from Mid-plane Joint of EXP

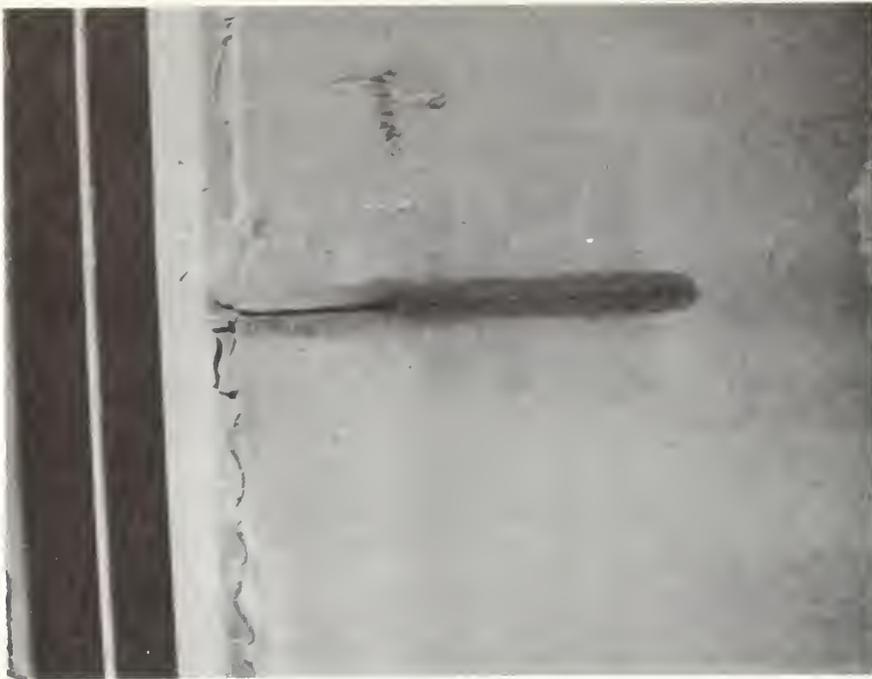
Fig. 2.22 Leakage Stain at Mid-plane Joint Near Edge of EXP

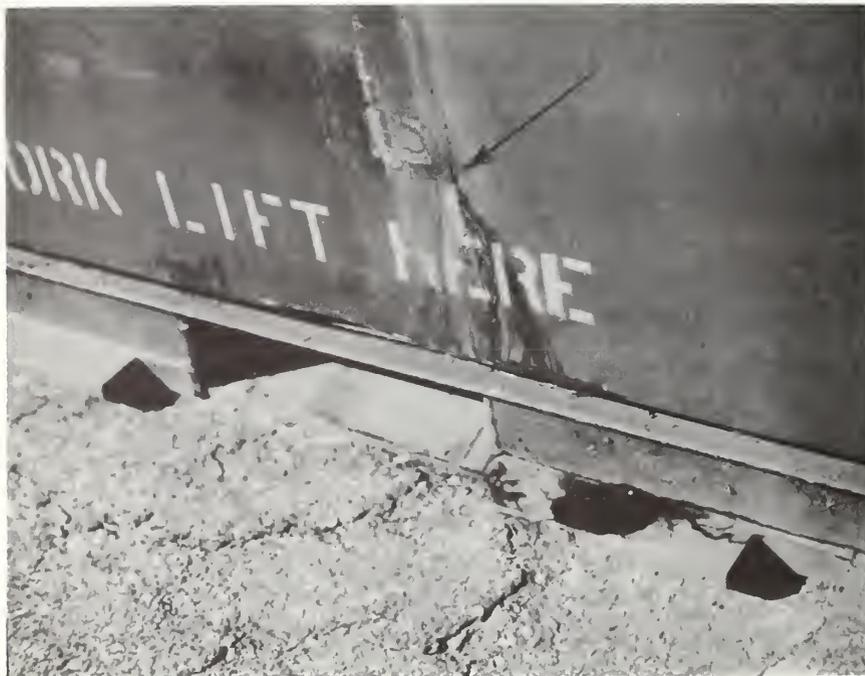
Fig. 2.23 Visible Water Leakage at Puncture in Facing of EXP

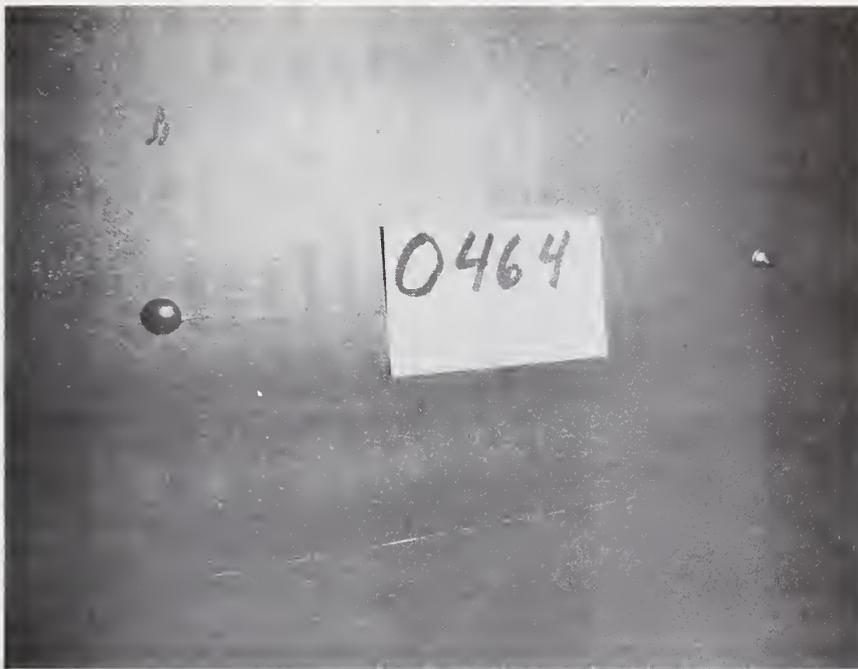
Two minor fabrication flaws, that had not been observed on the old ones, were observed on the new EXP's. These flaws were the result of the design change in the new shelters. The fabric floor covering had several blisters approximately 1/2 to 3/4 in diameter in the surface as seen in figure 2.24. These blisters appeared to be of air probably entrapped during the manufacturing process. The blisters were probed to determine if any liquid was present, but none was found.

Fig. 2.24 Blisters in Floor Covering Material
- New EXP

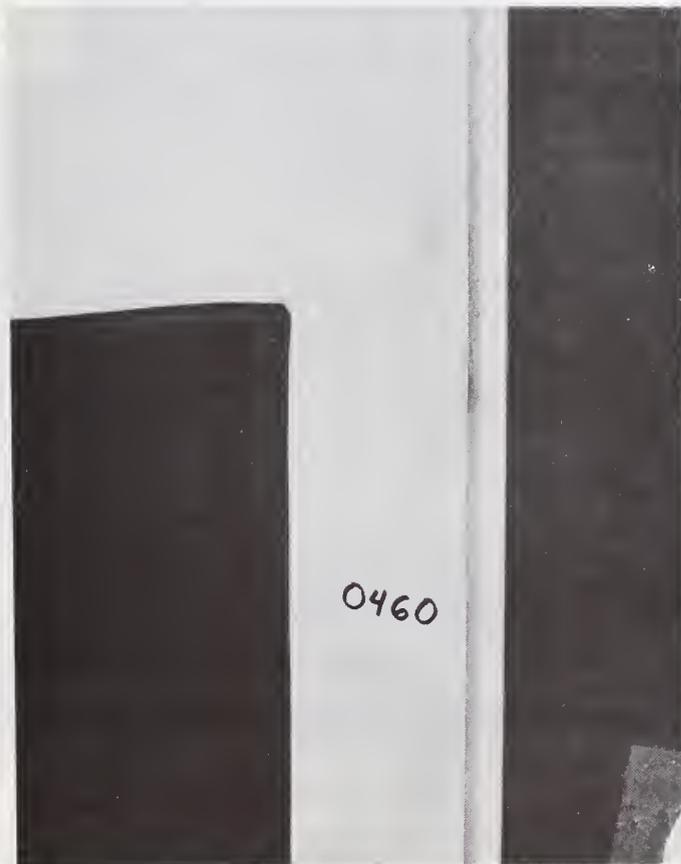
The other flaw noticed was a black discoloration of the white finish on the interior of the exterior end wall of shelter No. 0464. This dark discoloration is visible in figure 2.25. It was not possible to determine what this discoloration is or how it became prominent. The discoloration appeared to be within the finished surface and was not water staining or fungus growth on the surface.

Fig. 2.25 Discoloration on Interior Wall Panels
- New EXP

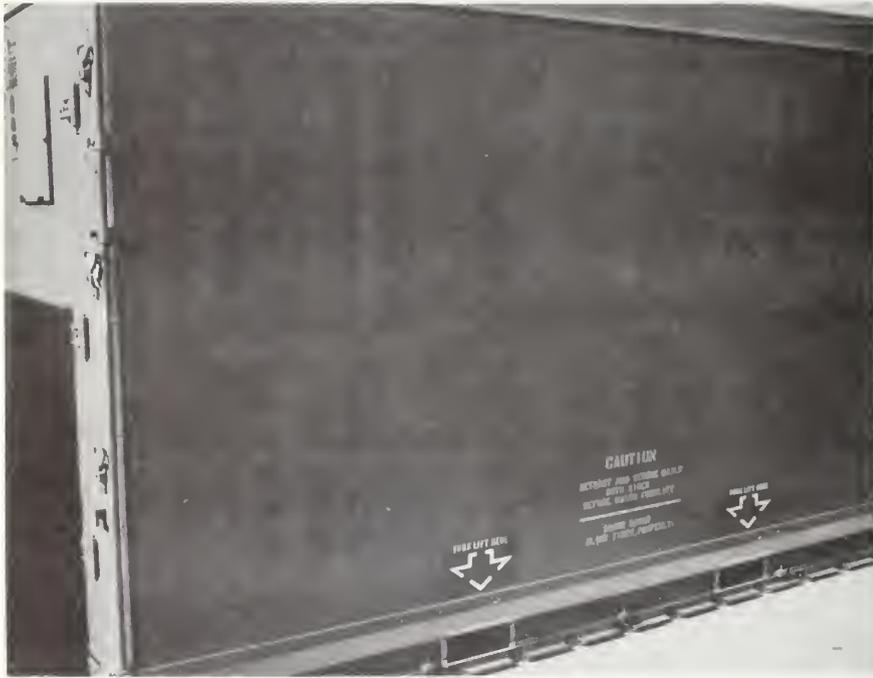
The reason that these two shelters were chosen for close inspection is that their fold-down floor panels were good examples of two conditions which were common to most of the newer ES/C's. At some places in a panel the facing between the internal beams was depressed below the level of the beams while, at other places the facing was bulged above the beam level (figure 2.28). The occurrence of these two conditions in the same panel seems to indicate that lack of foam-thickness tolerances during fabrication may be the cause.

In general, it can be said that, of the two conditions noted above, bulging of the facing is the dominant condition. For this reason it seems likely that foam-growth, sometimes exhibited in foam panels, is the primary factor in the out-of-planeness.

Fig. 2.28 Bulging of Foam and Beam Floor Panels
- Newer ESC

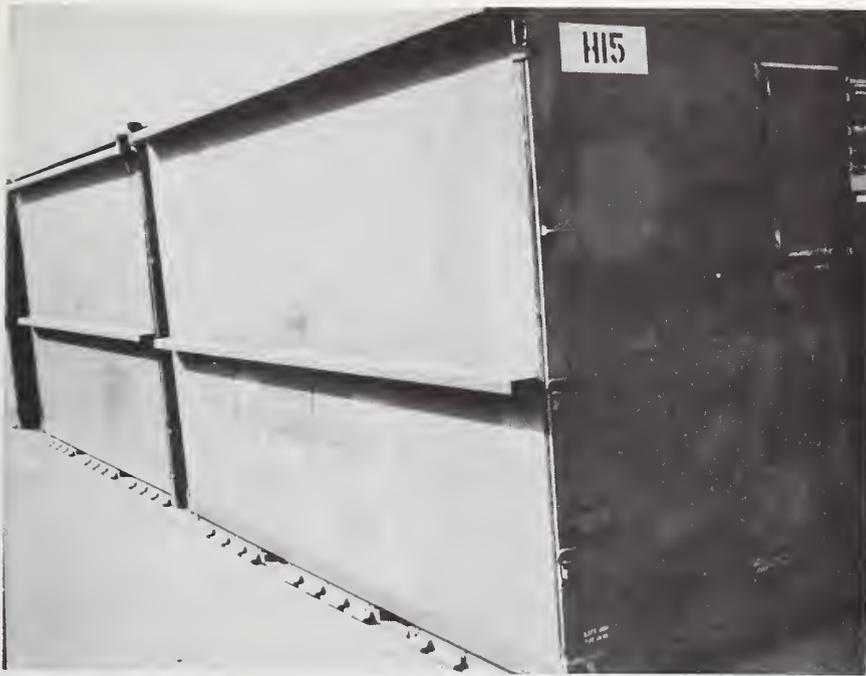
The greatest single defect observed during the inspections of the old ES/C's was delamination of the aluminum skin from the foam core material. The delaminations observed were on the exterior of the fold-down floor panels that serve as side walls during storage. The extent of the delaminations varied from slight to almost complete. For examples of delaminated areas in old ES/C's see figure 2.3a and also figure 2.26.

Fig. 2.26 Delaminations in Fold-down Floor Panel - Old ESC

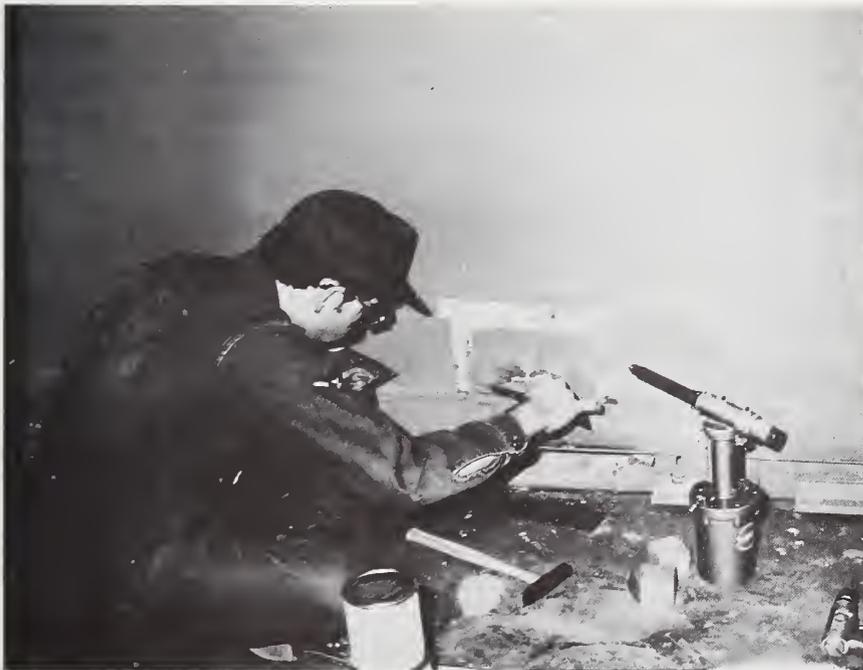
Fig. 2.27 Repair Being Made at Fork-lift Damage Point

1. The treated fabric weatherstrip closure over the roof panel hinge (figure 2.3a and 2.3b) on every ES/C shelter examined, had shrunk to the point where none of them could be properly closed to protect the hinge area from the weather.
2. All of the older shelters had indentations, mostly in the areas of lift-truck pickup points. None of the indentations is considered to be directly contributory to the extensive delaminations observed.
3. Extensive and varied repair procedures were observed on many shelters. Some of the repairs appeared to be field expedients. Figure 2.27 shows shop repairs being made at a fork-lift damaged area.

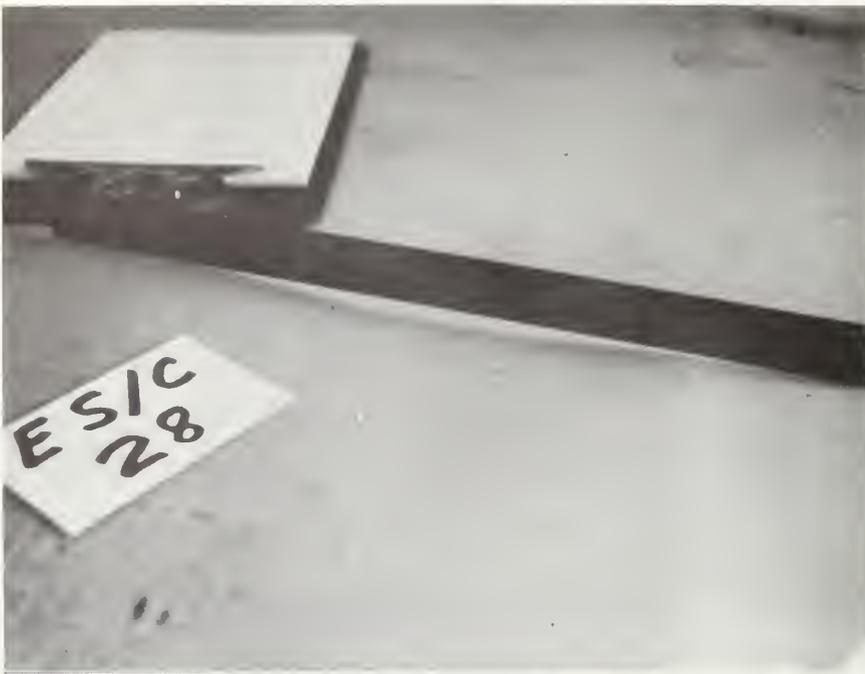
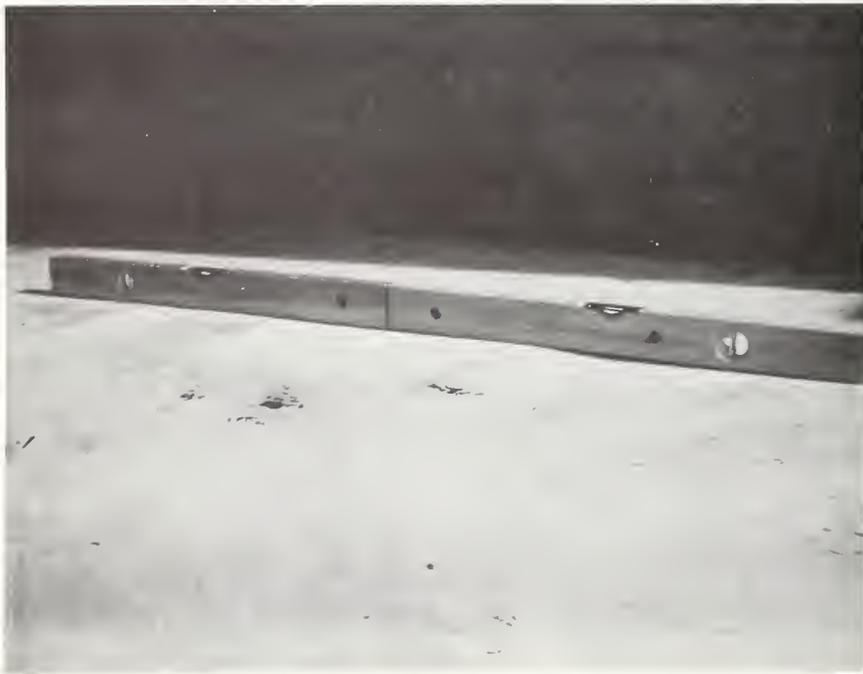
However, the floor panels that exhibited these conditions on the exterior were also distorted on the interior of the panel. On three of the four interior floor panels inspected, bulging of the facings was evident. Figures 2.29a and 2.29b depict the general magnitude of these bulging surfaces. Accurate measuring devices to profile the surfaces of the floor sections were not available but bulging as much as 3/4 inch out of the intended plane was noted.

Fig. 2.29 Bulging of Interior Facing on Foam and Beam Floor Panels - Newer ESC

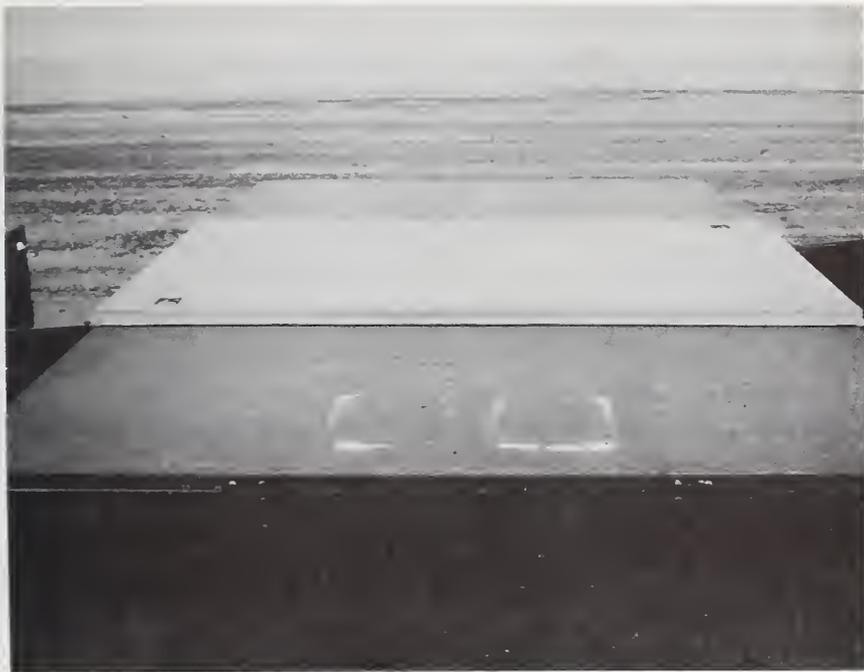
Fig. 2.30 Paint Deposits on Roof Panel of Newer ESC

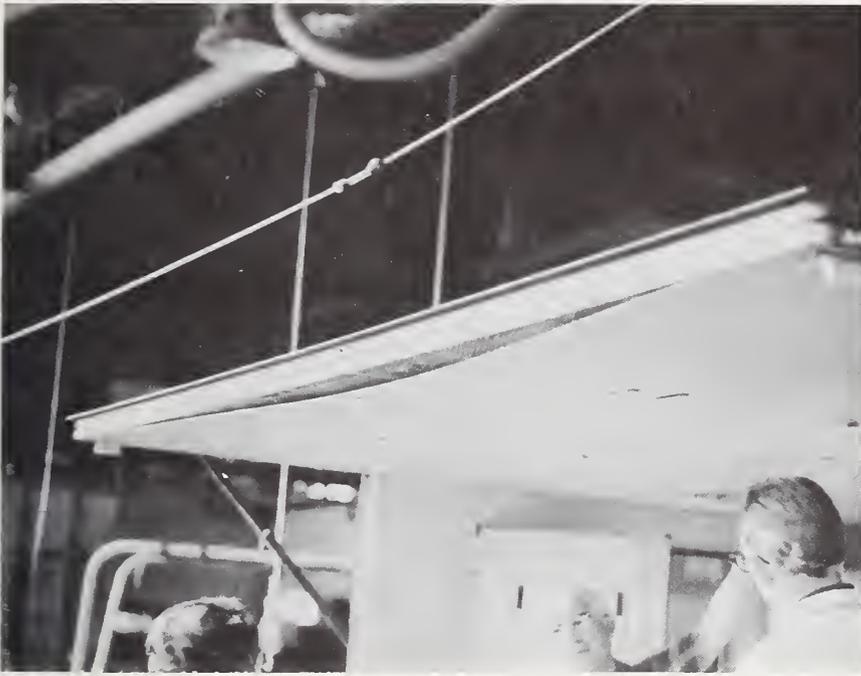
These shelters were made from honeycomb panels and many panels had delaminations (figure 2.32) which made the shelters unusable for their purpose. All of the MUST shelters inspected appeared to be well-used and were about 5 years old. There were punctures in the facings of some panels, predominantly in floor panels (figure 2.33), but no correlation between these punctures and delaminations could be found. In fact, the punctured panel of figure 2.33 was not delaminated. It should be noted that punctures are normally repaired by field personnel and it is possible that the delaminated panels did have punctures at some time.

Fig. 2.32 Delamination of Honeycomb Panels
- MUST Shelters

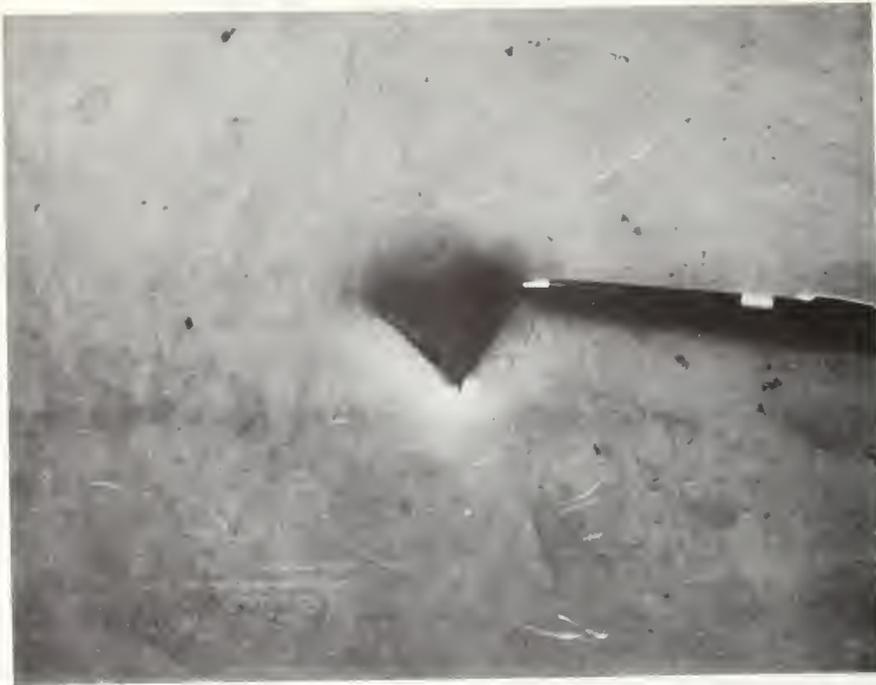
Fig. 2.33 Puncture in Floor Panel of MUST Shelter

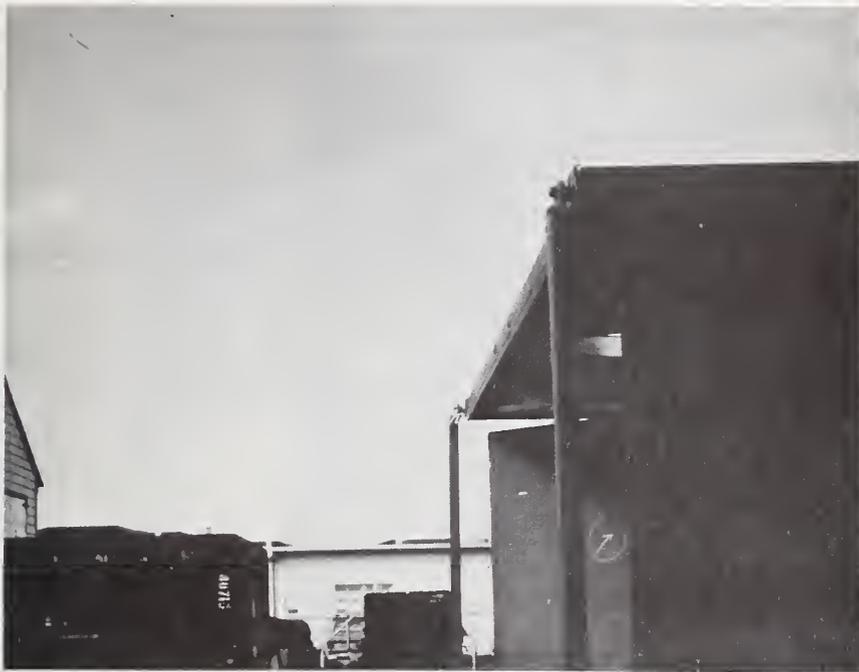
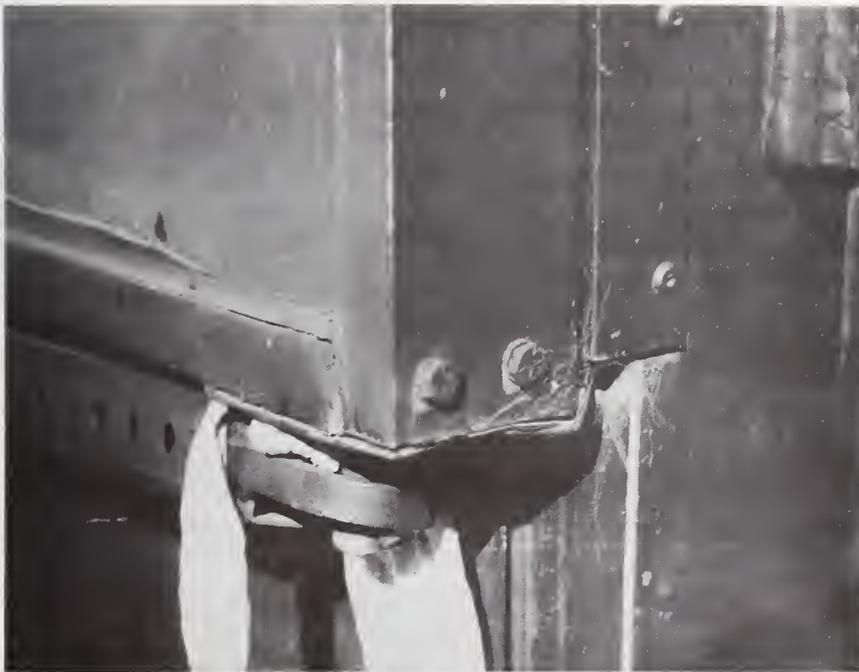
Fig. 2.35 Roof Support Bracket Failure of MUST Shelters

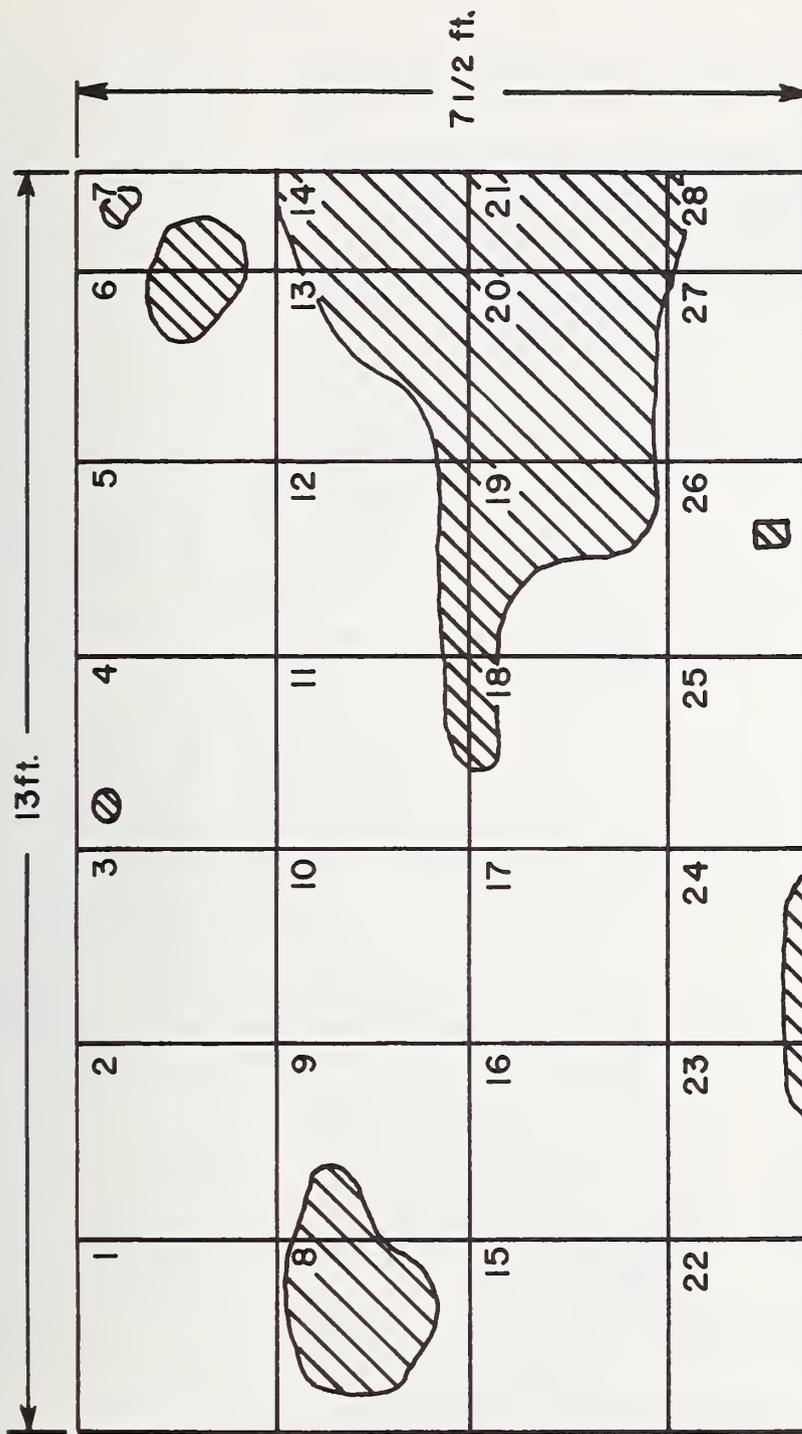
It should be pointed out that portions of the mid-height splices in the exterior facings of the 14R and 14L floor panels were loose so that water could penetrate. Major delaminations were found near these loose splices, especially below the splice (figure 3.7 and 3.8). From these two figures it appears that the upper corners of these panels were also vulnerable to delamination. Only minor delaminations were found on the center-structure panels, as indicated on figure 3.9, although the delamination at the bottom of the front panel (Panel No. 1) might have caused structural problems if the shelter had been dropped.

Fig. 3.7 Delaminations of exterior facing on EXP Panel 14 R

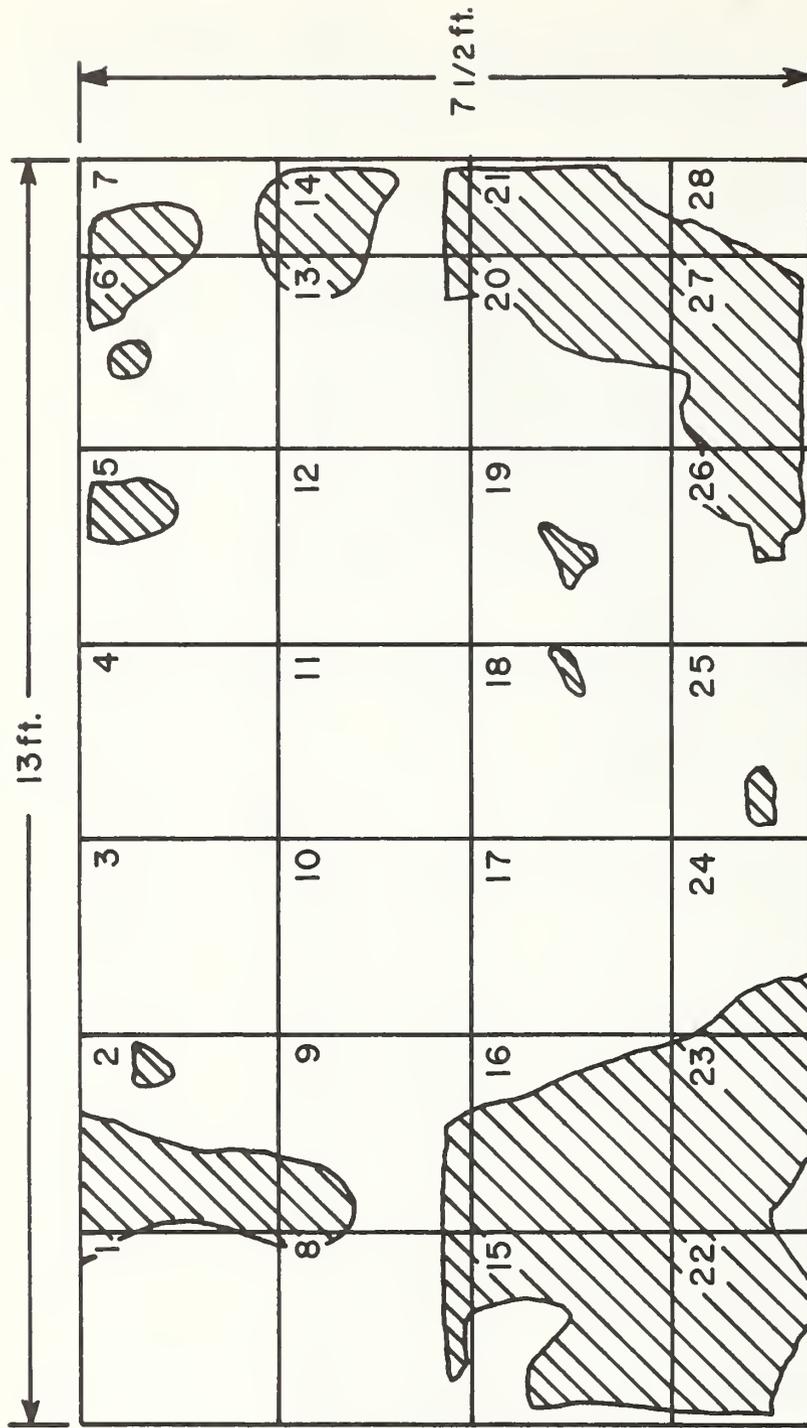
Fig. 3.8 Delaminations of exterior facing on EXP Panel 14 L

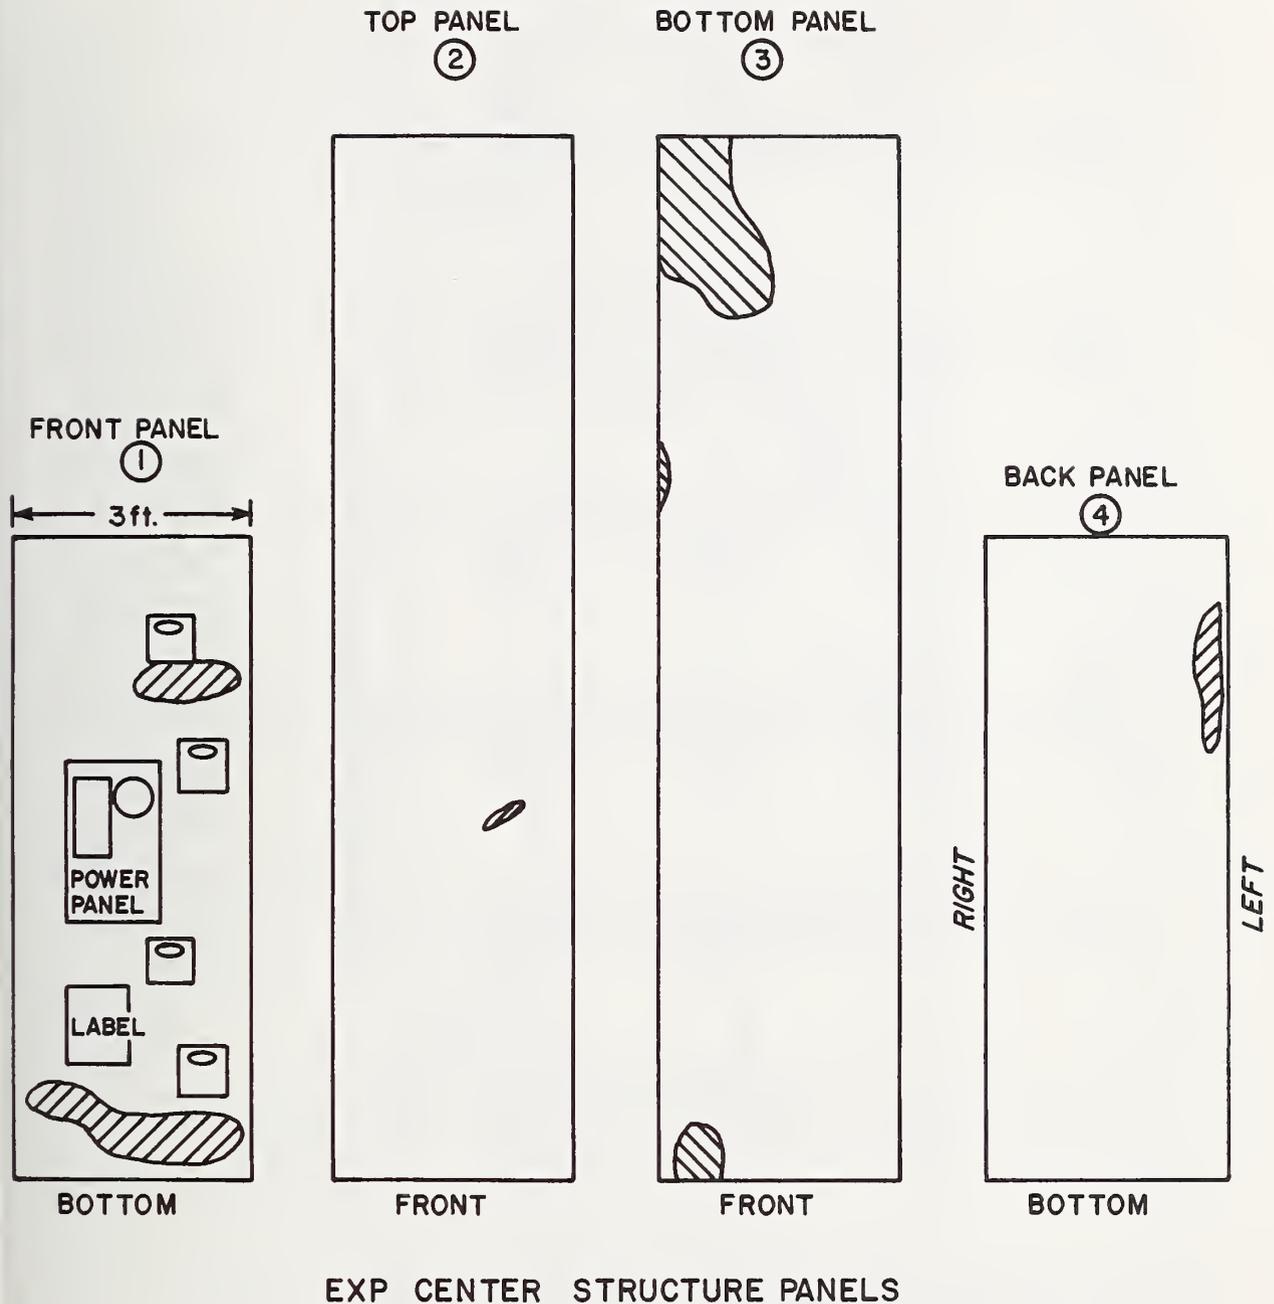
Fig. 3.9 Delaminations of exterior facings on EXP center-structure panels

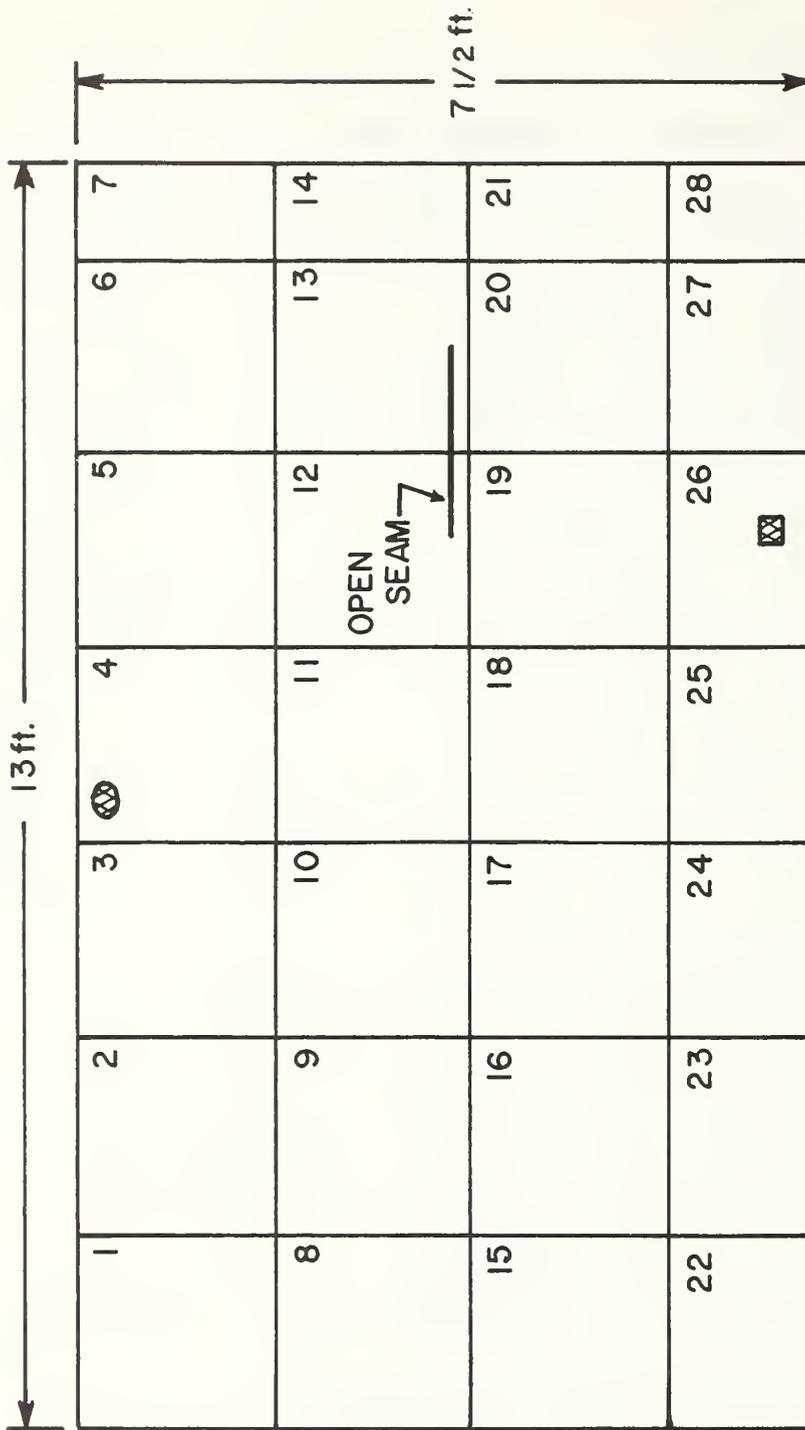
Fig. 3.10 Indentations and damaged areas on exterior of EXP Panel 14 R
